PA-479 DAM

NDI I.D. NO: PA-509

PHASE I INSPECTION REPORT
NATIONAL DAM INSPECTION PROGRAM

✓ D'APPOLONIA CONSULTING ENGINEERS
10 DUFF ROAD
PITTSBURGH, PA. 15235
MARCH 1979

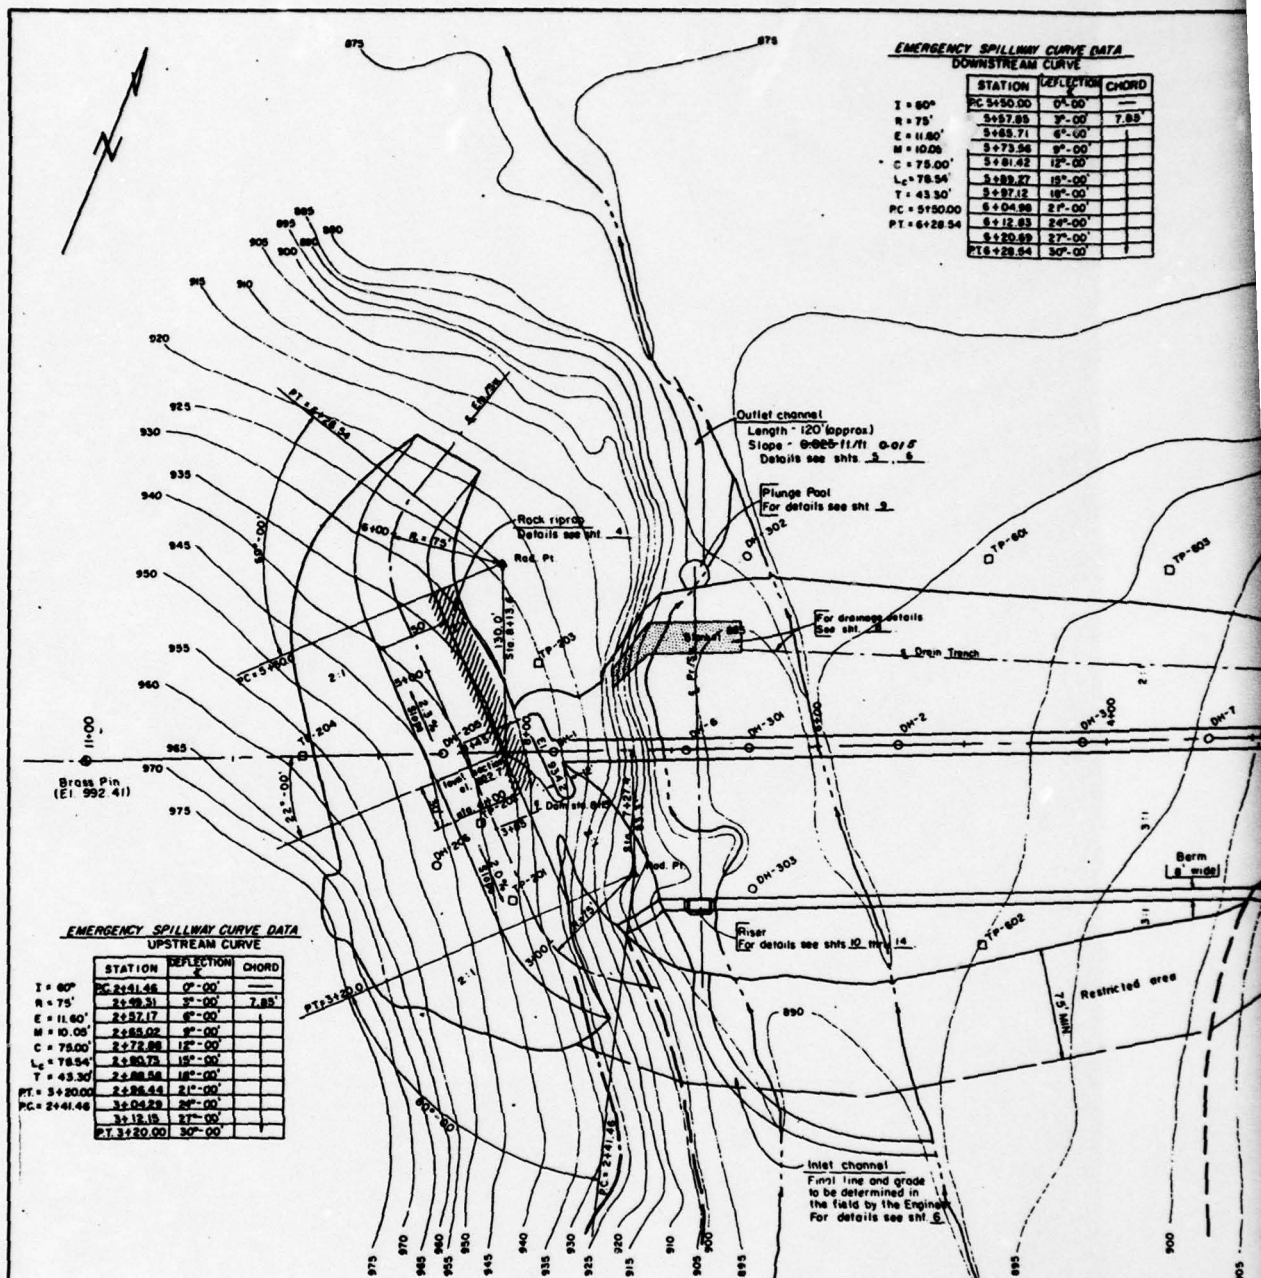
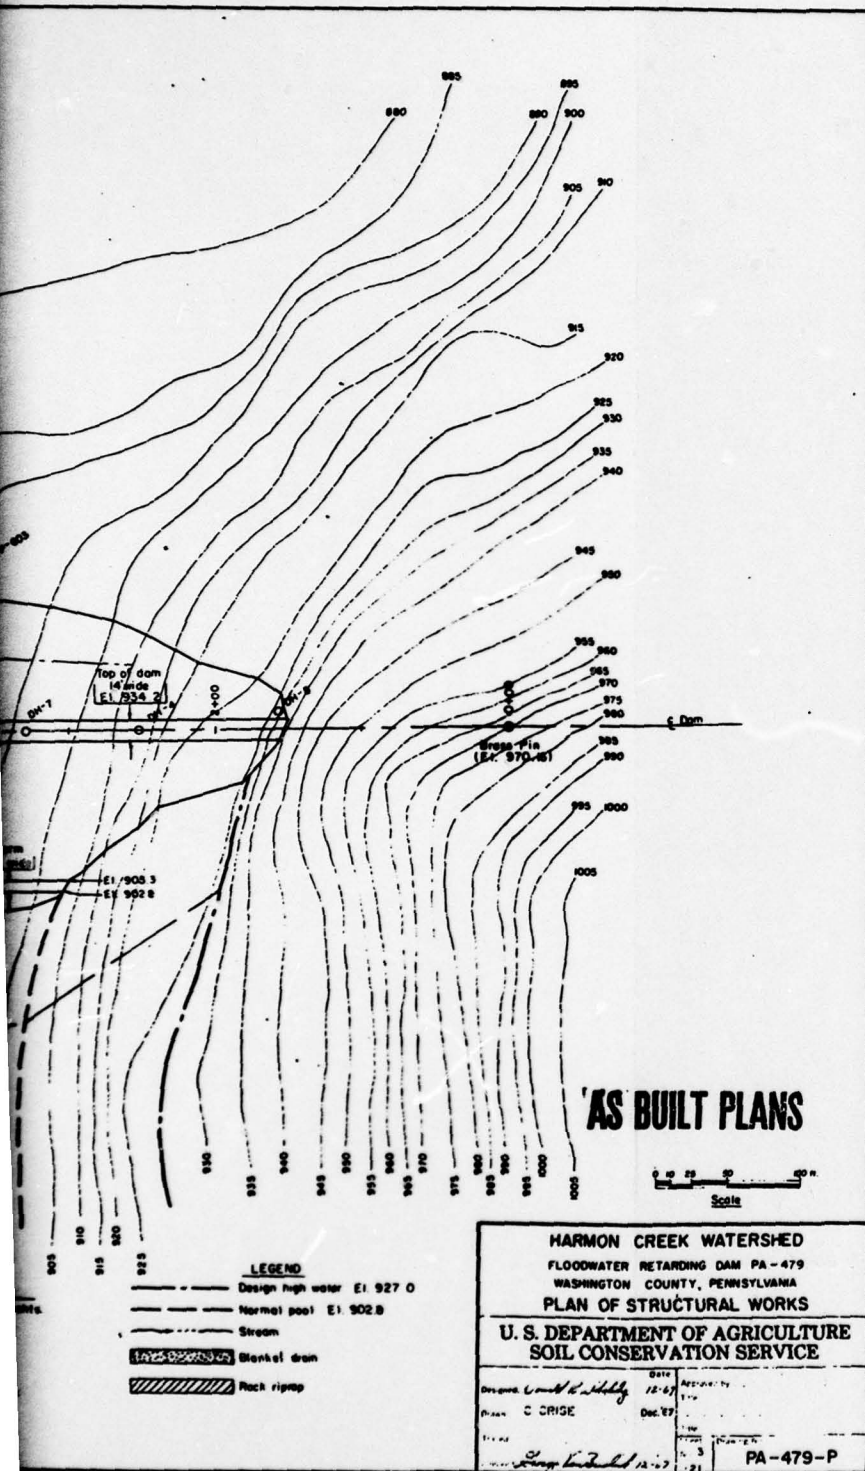
PLATE 2

a. As designed, the dam (Plate 2) is a homogeneous embankment with a central cutoff trench and a trench drain beneath the downstream slope (Plate 3). The cutoff trench, with a bottom width of 17 feet, was extended 5 to 10 feet below original ground along the valley floor. On the abutments, the width of the cutoff trench was reduced to 12 feet and the depth was approximately 5 feet. A 4-foot-wide, 10- to 15-foot trench filled with granular material located beneath the downstream slope constitutes the internal drainage system for the embankment (Plate 4). The trench drain starts at a level approximately 30 feet below the dam crest level and 40 feet downstream from the center line of the dam near the right abutment and terminates at a filter blanket near the discharge end of the outlet pipe at an elevation approximately 55 feet below the dam crest and 64 feet downstream from the center line of the dam. Over the lower half of its length, the trench drain is equipped with a 12-inch-diameter perforated drainpipe. On the left abutment, the internal drainage system consists of a minimum 2-foot-thick drainage blanket. This drainage blanket

- c. The subsurface investigation conducted for the dam consisted of numerous borings and test pits. The locations of these borings are shown in Plate 2. Selected boring logs are illustrated in Plates 5, 6 and 7. The typical subsurface profile (Plate 8) consists of up to 5 feet of medium to stiff sandy clayey silts on the valley slopes and about 10 to 30 feet of alluvium in the valley bottom. The alluvium is classified as medium dense to dense clayey gravels and clayey sands containing 33 to 56 percent gravel. The bedrock at the dam site consists of thin-bedded Birmingham Shale on the abutments and Pittsburgh Red Bed Shale underlying the valley bottom. The shales were separated by 2- to 3-foot-thick layers of Ames Limestone. The permeability of the bedrock varied between 0.1 foot per day and 8.6 feet per day (4×10^{-5} to 3×10^{-3} ft/sec). In general, the higher permeability rates were encountered in the valley bottom.

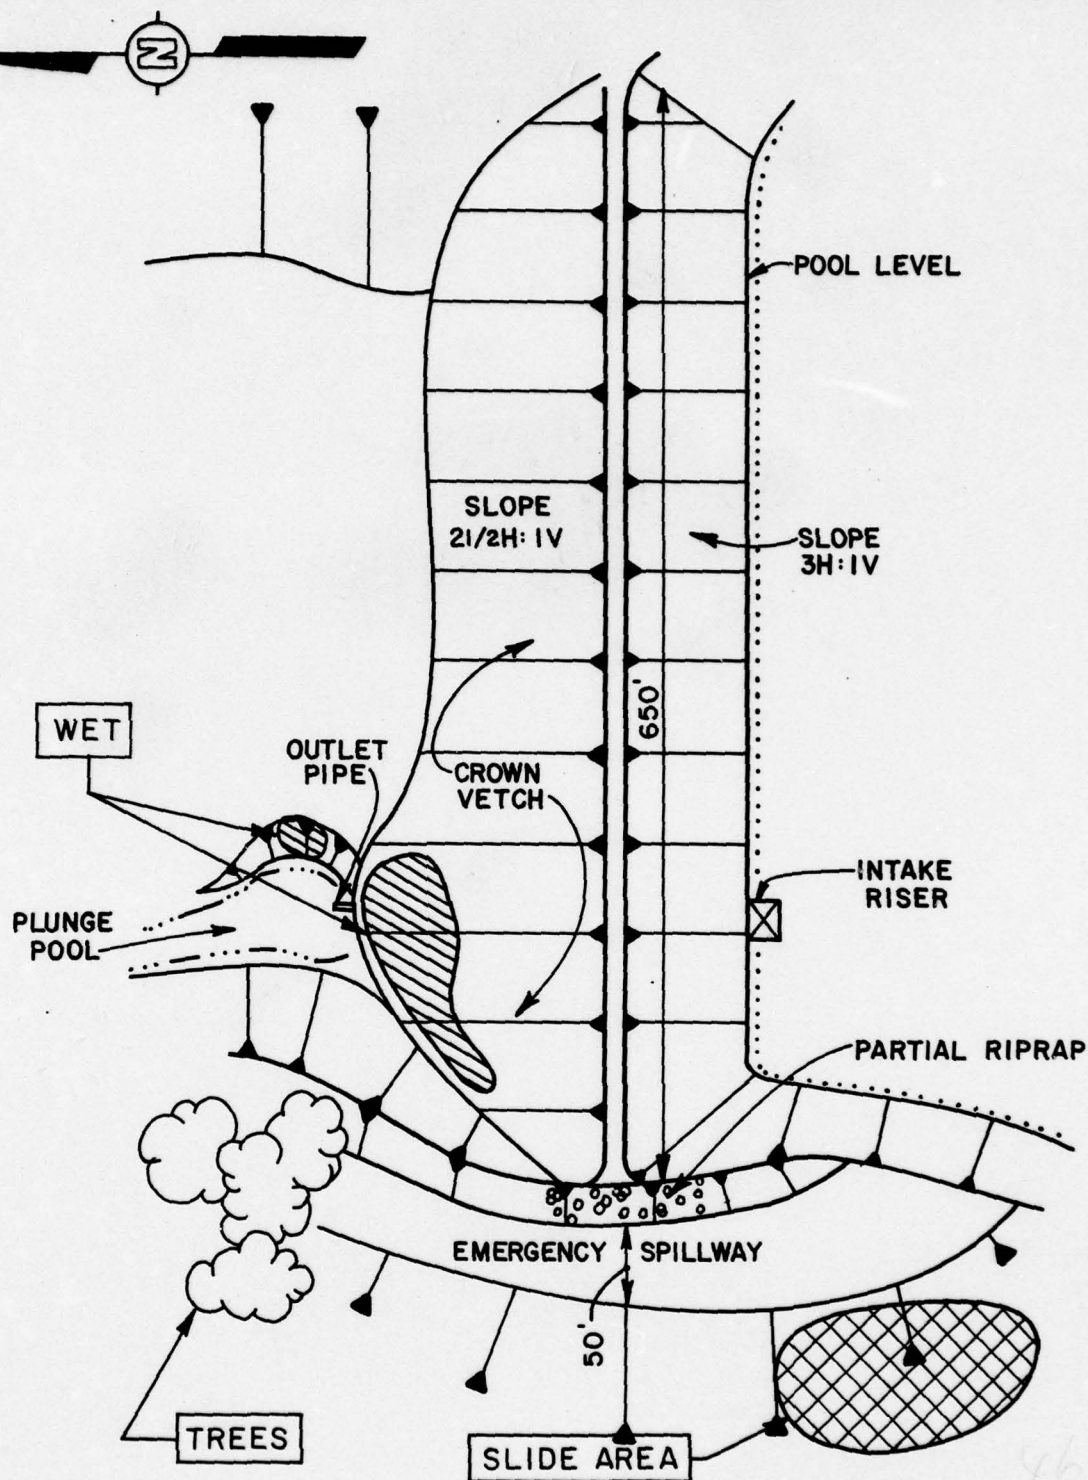
1. EMERGENCY SPILLWAY
FREEBOARD: 5.1 FT.
2. POOL LEVEL DATE OF
INSPECTION: 30.3 FT. BELOW
CREST OF DAM
